Railroad Investigation Report: RIR-25-12

Eliminate Fire Risk in the Southeastern Pennsylvania Transit Authority Silverliner IV Fleet

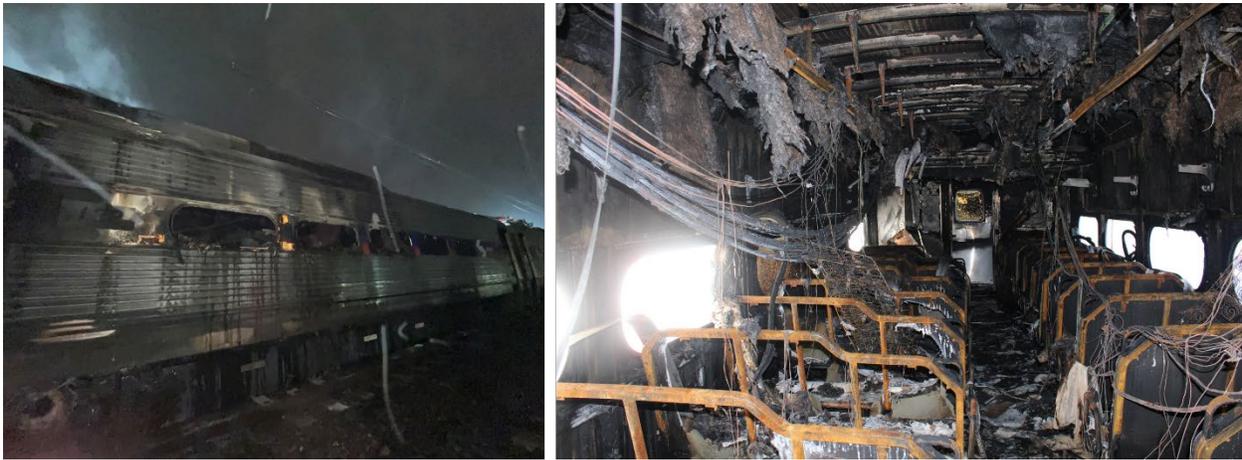
The NTSB's investigation is ongoing; however, preliminary findings indicate that the fire started in the railcar's undercarriage when electrical components associated with the train's propulsion system overheated and ignited.

Figure 1. External (left) and internal (right) damage to railcar following Ridley Park fire.

The investigation into the fire performance of the Silverliner IV railcars involved in all three fires is ongoing, but preliminary findings from the Ridley Park and Paoli fires indicate that fires spread from exterior electrical compartments to interior occupied compartments, a type of failure current design standards are intended to limit or prevent.

Suspend operation of the Silverliner IV fleet until you have determined the root causes of fires, developed and implemented a plan to address these causes, and identified and corrected the organizational factors that have prevented effective risk mitigations. (R-25-12) (Urgent)

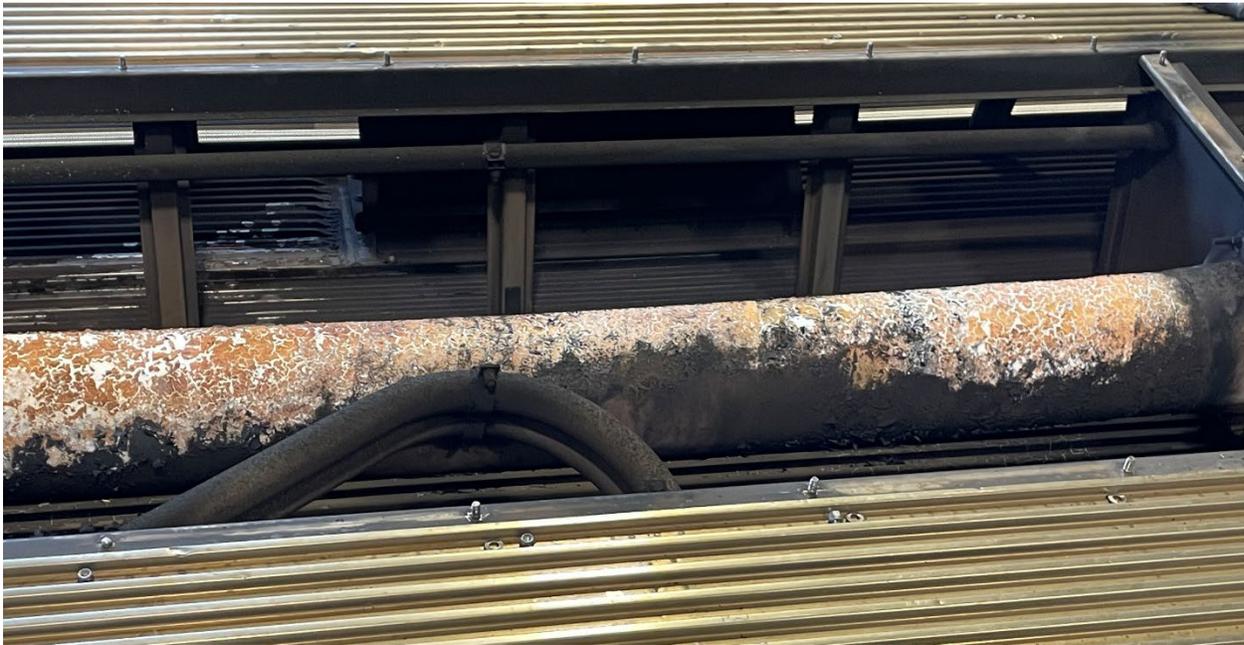
The second incident occurred on June 3, 2025, in Levittown, New Jersey, about 7:10 a.m., when the rearmost railcar of SEPTA train 7206 caught fire as the train stopped at Levittown Station. Train 7206 consisted of five Silverliner IV railcars and had about 150 passengers on board. The crew evacuated the train's passengers, and no injuries were reported. The crew did not report a fault light before the fire. The fire was mostly confined to the roof area of the railcar and a rooftop ventilation duct (see figure 2).

As part of the investigation into the earlier Ridley Park fire, the NTSB examined the damaged railcar from Levittown and found signs of overheating on the dynamic brake resistor banks, which normally convert mechanical energy into heat when the dynamic brakes are applied.³ Preliminary findings indicate that a cam controller pilot motor (part of the system that controls the railcar's dynamic brakes) failed and that the dynamic

braking pressure switch (which engages or cuts out the dynamic brakes during air brake applications) was out of calibration. Together, these two issues allowed this railcar's braking system to become stuck in dynamic braking mode as the train remained in motion and under power, causing the resistor grid to overheat and ignite a fiberglass rooftop ventilation duct.

Figure 2. Fire-damaged ventilation duct on railcar following Levittown fire.

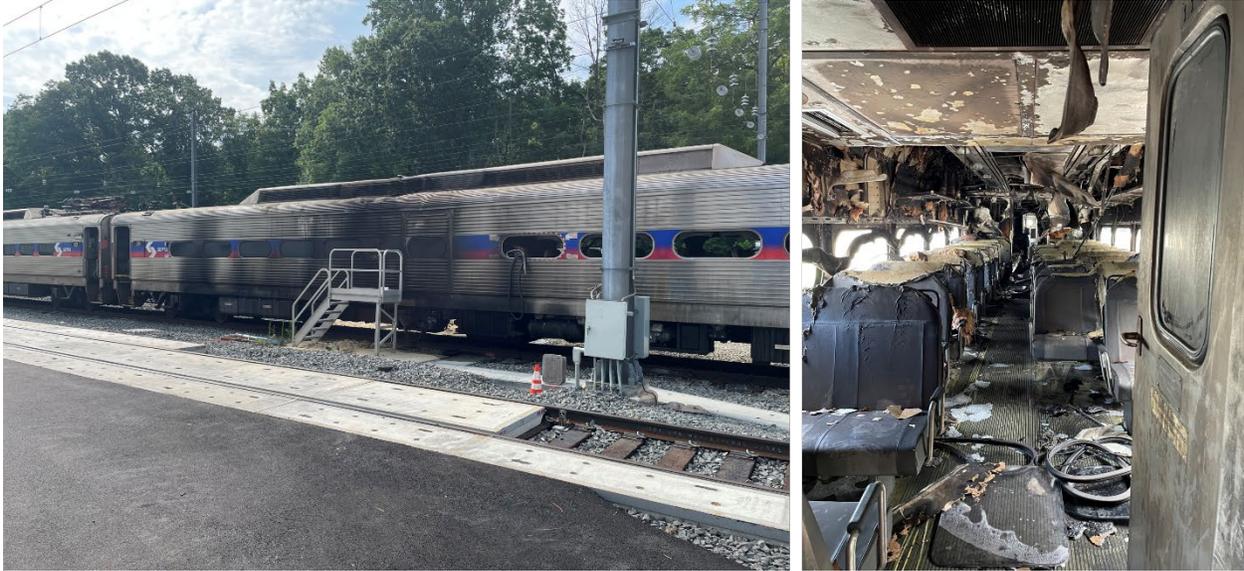
The third incident occurred on July 22, 2025, about 10:53 p.m., when the fifth railcar of SEPTA train 3553 caught fire as the train stopped at Paoli Station in Paoli, Pennsylvania. Train 3553 consisted of six Silverliner IV railcars. Two crews operated the train in the hours before the fire, and both crews reset the fault light at least once. When interviewed by the NTSB, both crews said they reported slow acceleration to the dispatcher, but the train remained in service. The second crew discovered the fire when the train lost motive power and the conductor left a railcar near the front of the train to reset the fault light again, encountering smoke in the rear railcars. The crew evacuated the train's 14 passengers. The conductor was transported to a local hospital for treatment for smoke inhalation; no other injuries were reported. The railcar that caught fire was destroyed (see figure 3). The NTSB examined the involved railcar from train 3553, again as part of the ongoing investigation of the Ridley Park fire. Preliminary findings indicate that the fire began in the undercarriage with electrical components in the train's propulsion system and spread to the passenger compartment, similar to the February 6 fire in Ridley Park.

Figure 3. External (left) and internal (right) damage to railcar following Paoli fire.
